Moffett Field Golf Club
Environmental Baseline Assessment
Moffett/Onizuka AS, CA **Jul 05**

Executive Summary

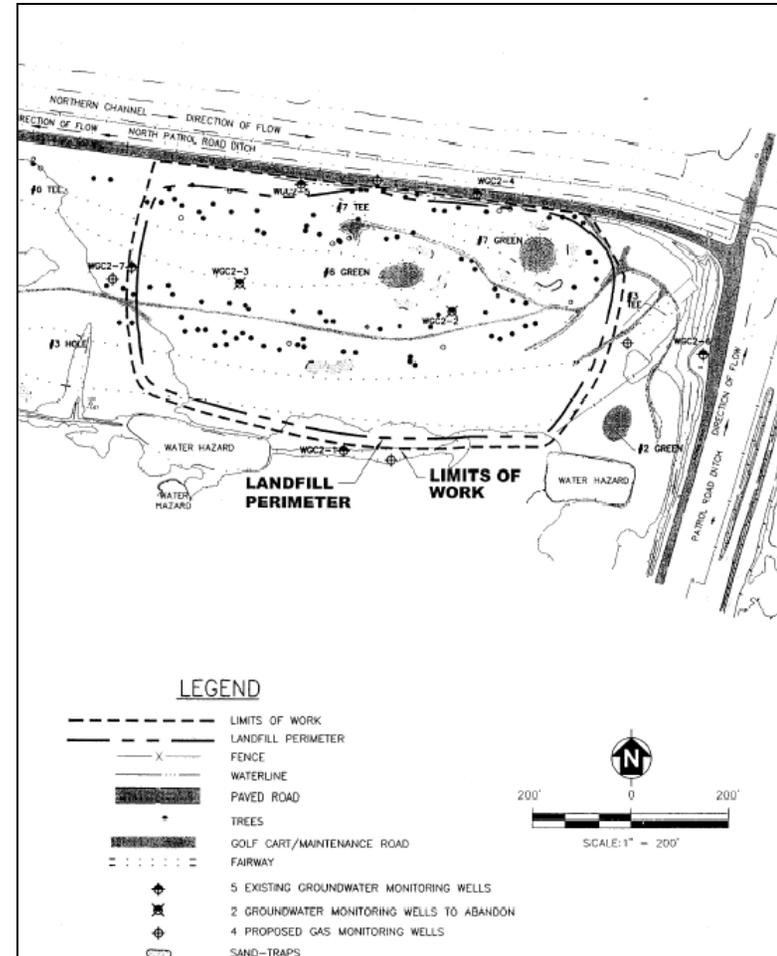
This excerpt from the Navy's proposed plan for Site 22 illustrates the work performed at Moffett Field Golf Club to restore the landfill site.

A former Navy installation, Moffett Field was designated a Superfund site in 1987. Site 22 landfill is located under the 3rd, 6th, 7th, and 8th holes just

south of the Cargill Salt Pond. Located on the northernmost edge of the golf course property, the 9.4 acre site was operated from 1950-1967. Contamination includes VOCs, SVOCs, pesticides, total petroleum hydrocarbons, and metals. A biotic barrier was the preferred alternative cleanup remedy. The work has been completed and the affected holes have been reconstructed. The new greens will require slightly different agronomic practices as a result.

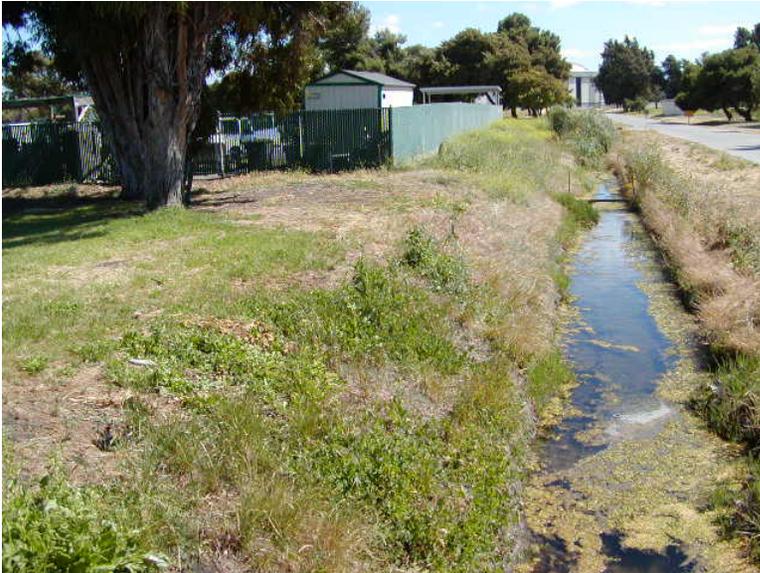
This drainage ditch abuts the maintenance complex and receives stormwater runoff from it as well.

Water quality concerns include surface water, lakes, ponds, drainage ditches, groundwater, and stormwater. The INCRMP states that “all groundwater of the state to be suitable, or potentially suitable, for municipal or domestic water supply, including the shallow aquifers in the vicinity of Ames (Moffett Field/Onizuka AS). The possibility of contamination of these water resources exists largely because of the relative shallow depth to groundwater. Any chemical or fertilizer application should continue to consider potential negative impacts.

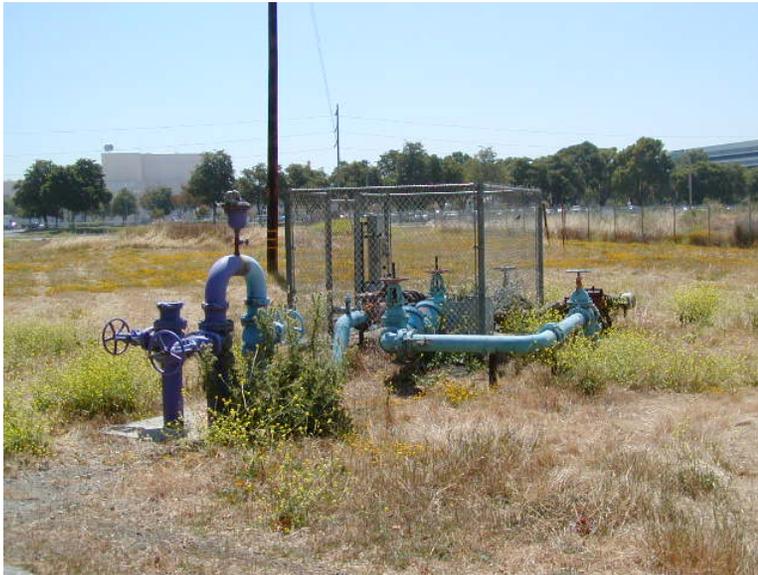
The purple pipe in the foreground is recycled water. A simple connection to the pipes beyond and the course will stop using drinking water supplies for irrigation purposes.

Potable water use for golf course irrigation is nearly always an environmental issue. This is definitely the case at Moffett Field Golf Club. Currently the club is irrigating with potable water paying NASA a flat fee annually. There is a recycled water source located nearby the course's potable water source that has not yet been connected. Accordingly, it may cost the installation, and eventually the golf course, more to water the course in the future.

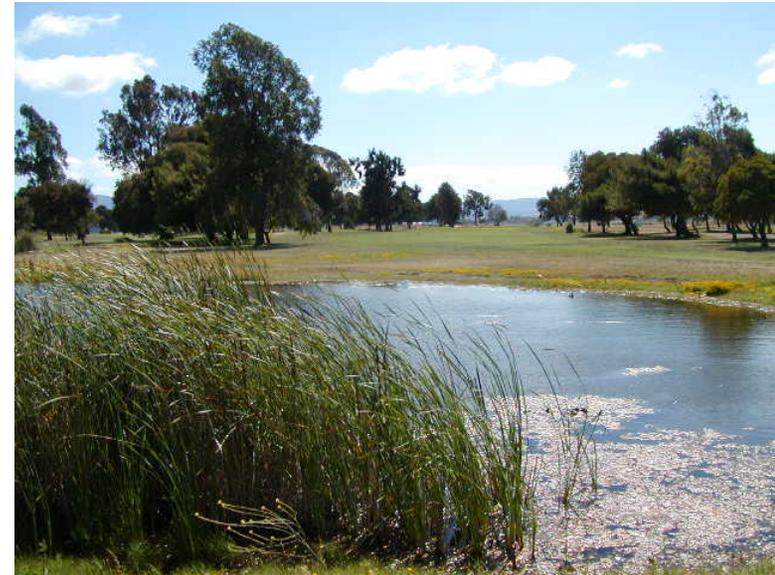
Vegetation management of water features encourages birds to stopover or loaf indefinitely.

Although the flying mission is limited at Moffett Field/Onizuka AS, the course's water features are not managed to minimize the potential for aircraft strikes. Assuming the reason is lack of funding rather than lack of desire, there may not be a good short term solution to this environmental challenge. Regardless of the minimal flying mission, BASH concerns are direct and to the point when it comes to the golf course facility. Management should at least consult with installation flying safety staffers to ensure they are doing the best they can with their limited resources.

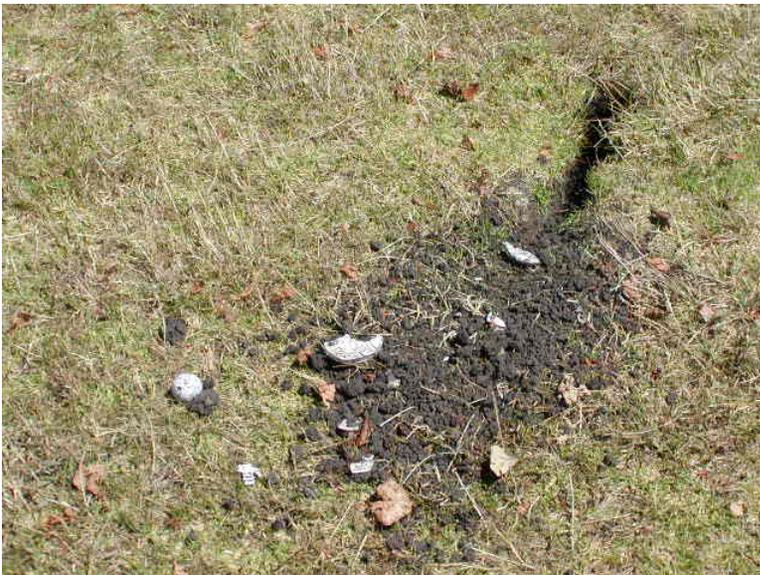
Whether owls or squirrels, there are holes throughout the course.

According to the INRMP, Moffett Field/Onizuka AS supports at least two species that concern wildlife biologists. The first, the California Black Rail, is not a concern for the golf staff. The second, the burrowing owl, is a significant concern as it has readily made the golf course its home. The NASA property is reputed to be home to at least a quarter of the San Francisco Bay area's population of burrowing owls. According to the INRMP, the endearing owls have been designated as a species of special concern by both the state of California and the U.S. Fish & Wildlife Service. Burrows are easily observable in some areas of the course. Moffett Field Golf Club management has not been allowed to fill burrow holes. This will be a challenge for the foreseeable future. Ground squirrels are also protected.

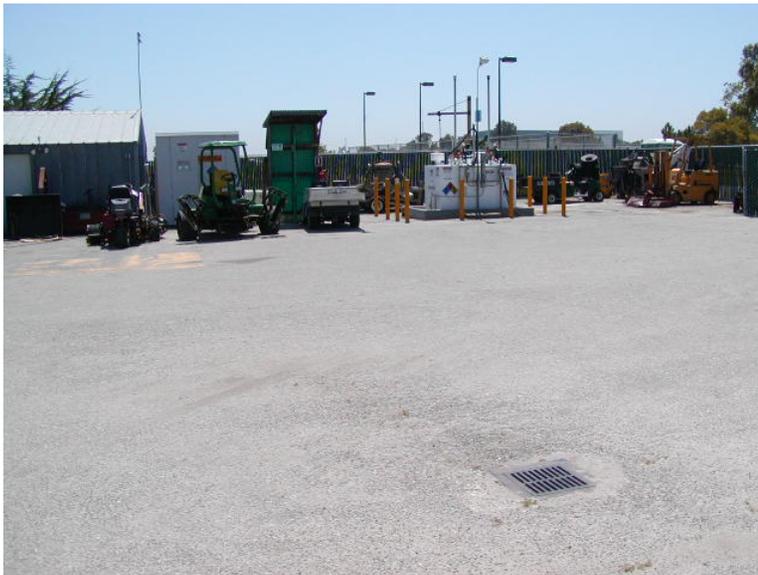
The maintenance complex's stormwater drain in the foreground is cause for concern for some Moffett Field environmental managers.

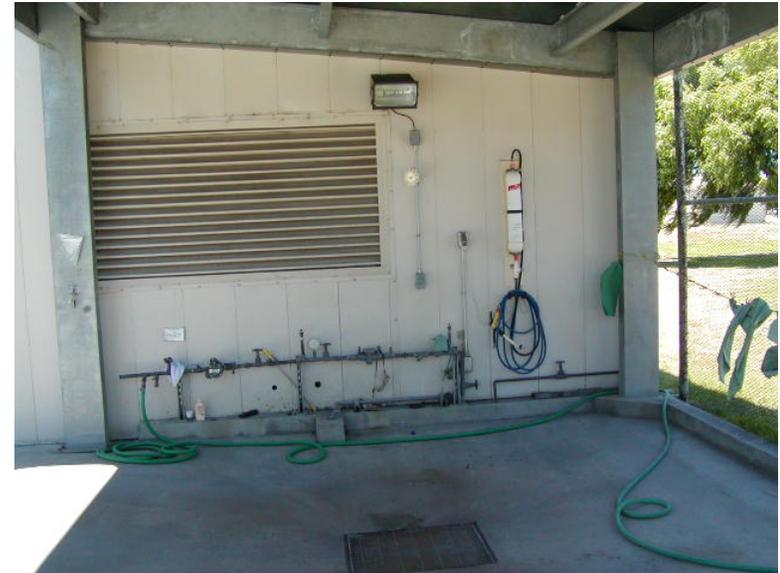
Golf cart wash rack is both efficient and environmentally compliant.

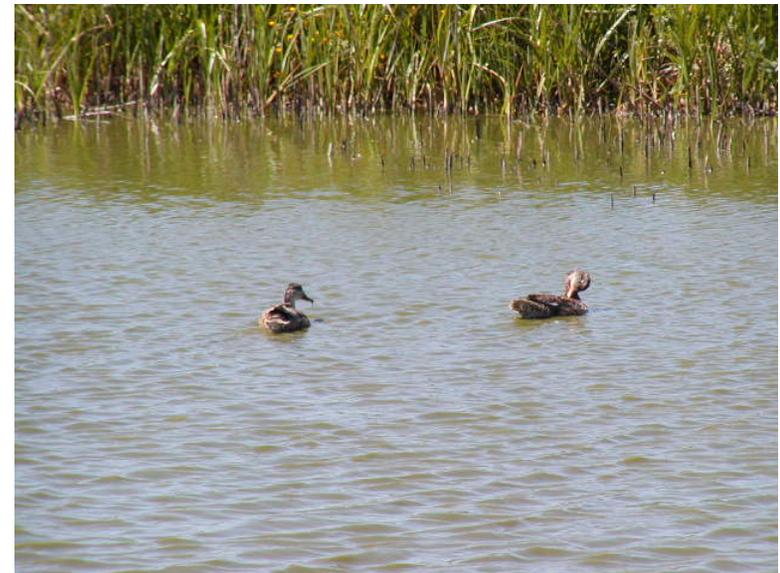
Water fowl enjoys Moffett Field's hazards more than their customers.

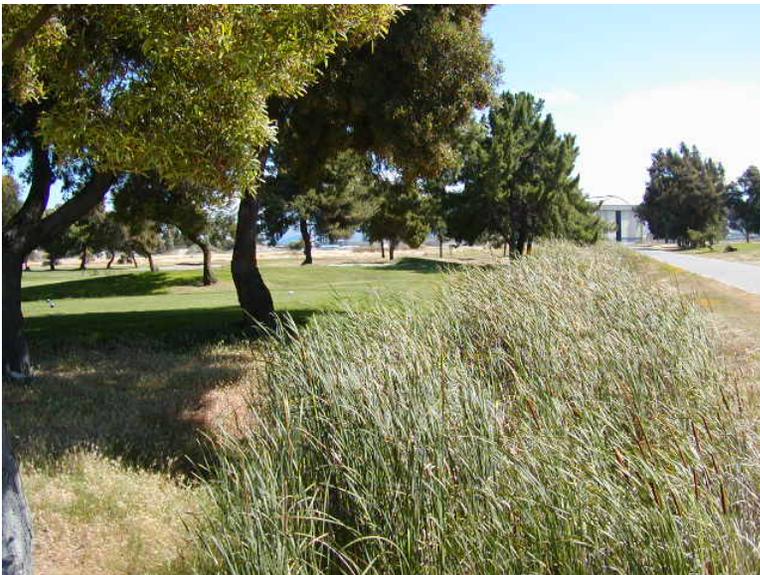
Vegetation severely limits this drainage structure to move stormwater.

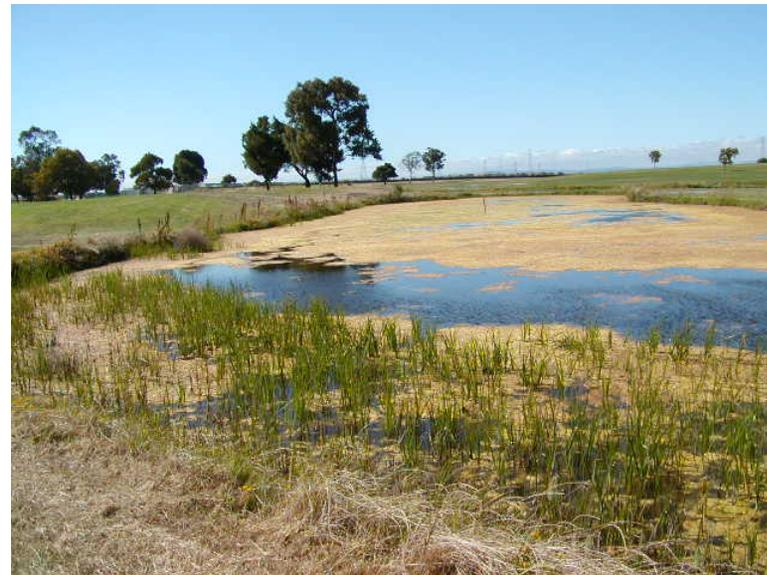
Water quality management is a difficult task at Moffett Field GC.

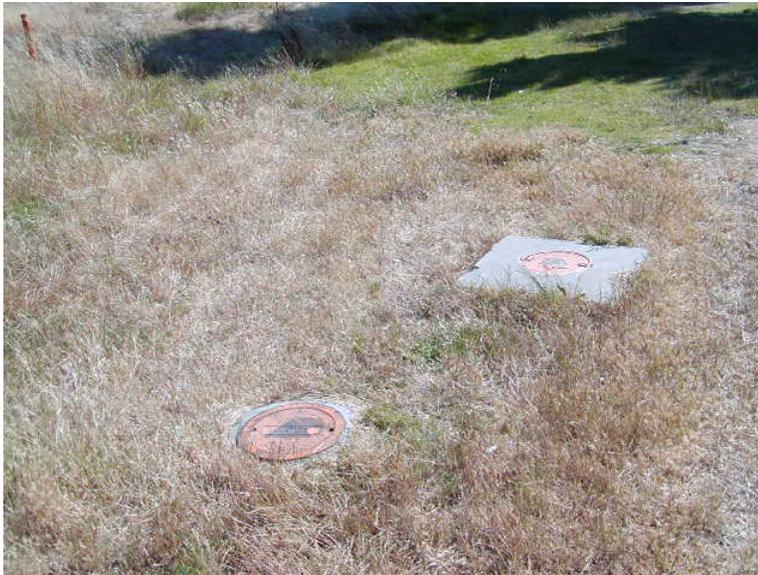
Monitoring sites may be the only legacy from the cleanup project.

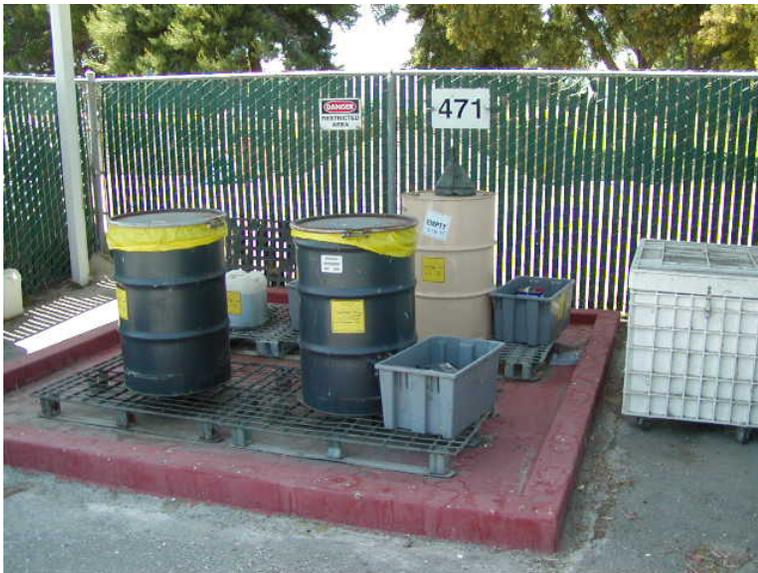
Setting the example for waste oil storage management.
