***Eglin Golf Courses***  
**Environmental Baseline Assessment**  
**Eglin AFB, FL      May 05**

# Executive Summary

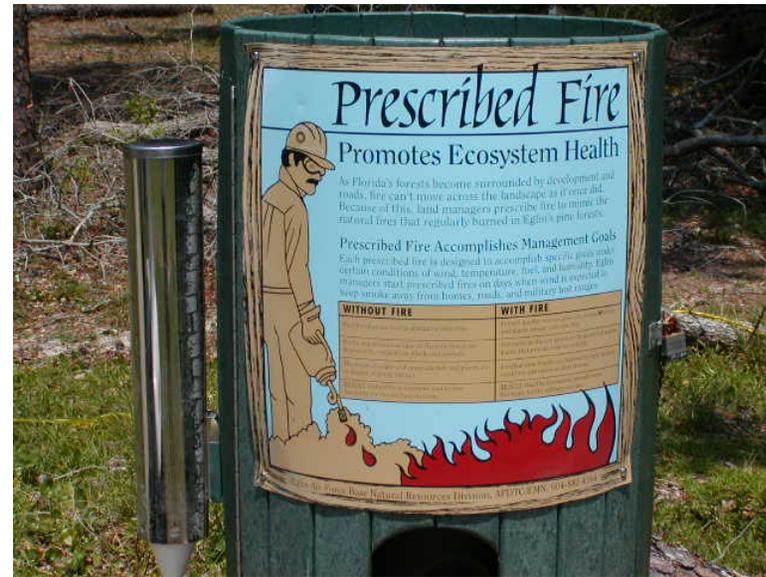
Eglin Golf Courses have the best environmental signage observed.

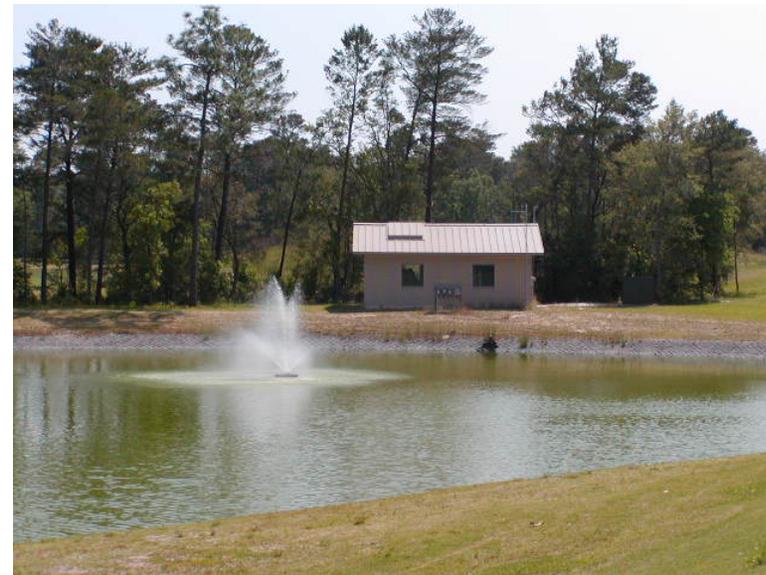
New irrigation supply pond and pump house on the Falcon Course.

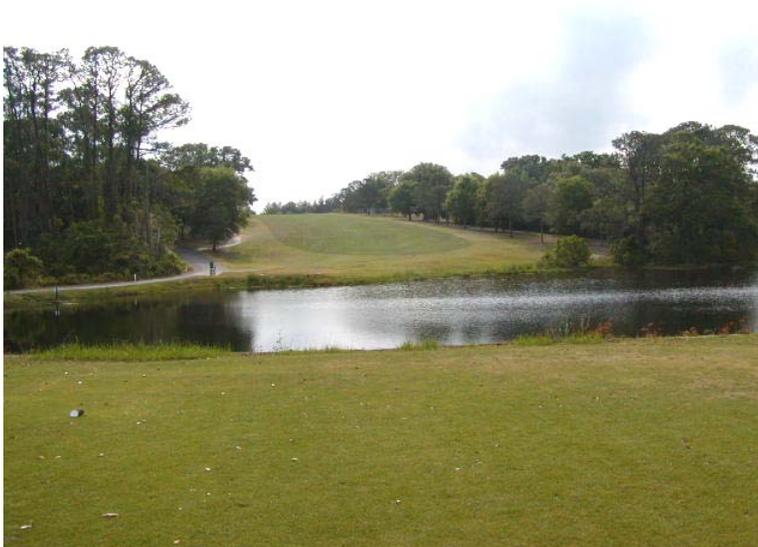
*Somewhere in the vicinity of the Eagle's 17<sup>th</sup> tee is a historical site.*

The lands now occupied by the Eglin Golf Courses have been in use for hundreds of years. After consulting with the installation archaeologist, Mark Stanley, at least the Eagle Course had not been recently evaluated for potential cultural sites. It is known that there was once a lumber operation near the current 17<sup>th</sup> teeing area that may have historical

significance. Mr. Stanley agreed that a scheduled complete site evaluation of the Eagle Course should be finalized soon in light of the pending greens renovation project.

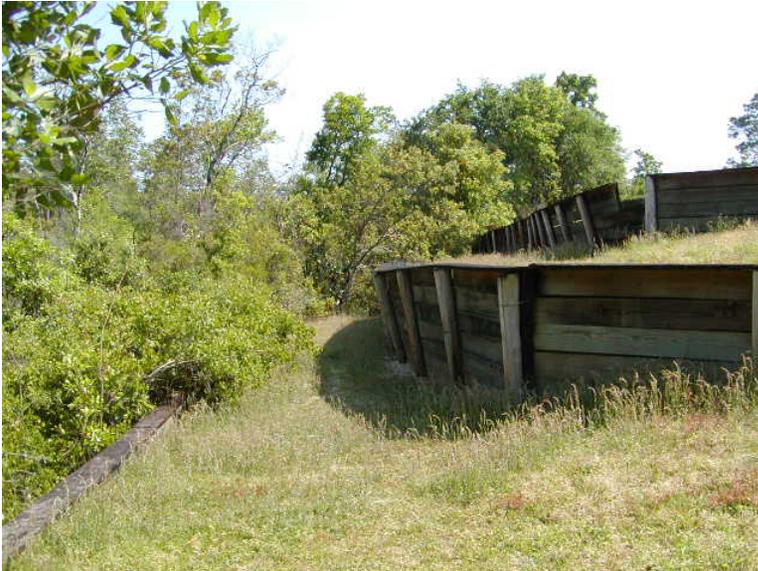
*Retaining walls at the Falcon's 9<sup>th</sup> hole will require engineering, environmental, and golf expertise and coordination.*

Diligent management of stormwater and the quality of a course's water features are always a prime consideration of environmentally-sensitive superintendents. Paul Wargo is wary of the potential impacts he and his staff may have on the natural resources of the area. Every aspect of his maintenance program is examined for

appropriateness and correct timing and delivery prior to taking action in the field. With the many animals living on the course and relying on the quality of the waters, not discounting the Okaloosa darter, Wargo's maintenance procedures are based on doing what is best for both the environment and the courses. A great example of where this attitude comes to fruition will be the repair of retaining walls in front of the Falcon Course's 9<sup>th</sup> hole. Every expertise required to rectify the situation has or will be taken to protect the water quality of the stream just downhill of the project.

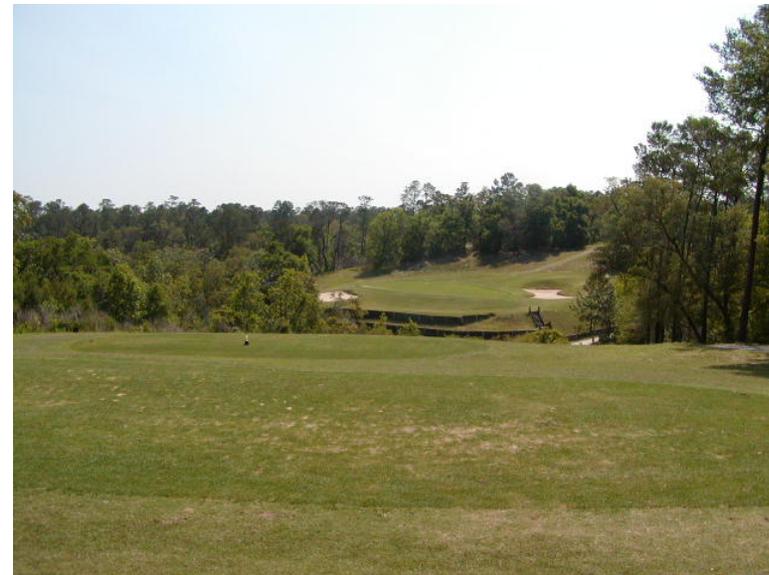
*The Falcon's 9<sup>th</sup> hole is a par three over one of the Okaloosa darter streams. Minimal impacts from erosion and runoff from reconstruction and long-term maintenance are paramount.*

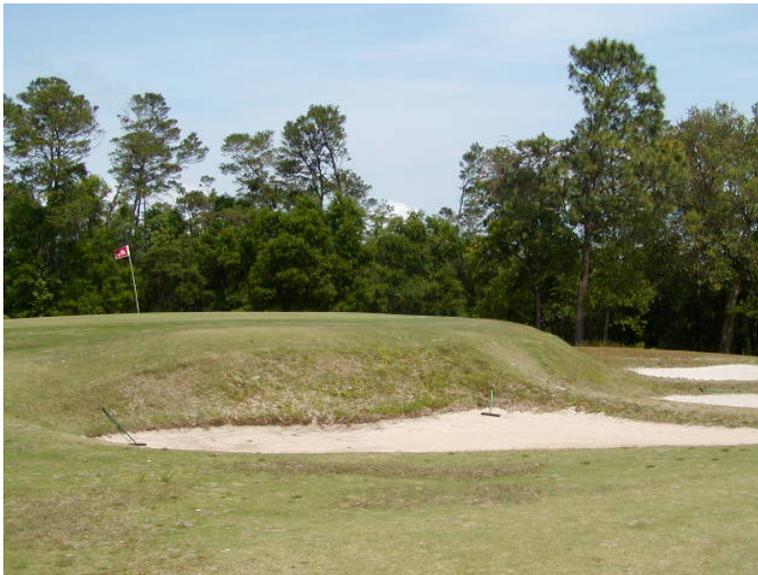
The Eagle Course has been identified as a candidate for a greens renovation project that may be started as soon as early FY06. Working with the installation environmental staff, the Director of Golf and his staff will need to complete an AF Form 813 to initiate the environmental impact analysis process. They also will need to have prepared a Stormwater Pollution Prevention Plan prior to construction beginning on the much needed project. Mitigative or restrictive instructions may have to be included in the design and construction package statement(s) of work depending on the conclusions of these two studies.

*Some of the greens at the Eagle Course are small and difficult to maintain due to poor drainage and soil quality. Renovation should eliminate or minimize potential impacts of pesticide and fertilizer applications as a result of building USGA greens.*

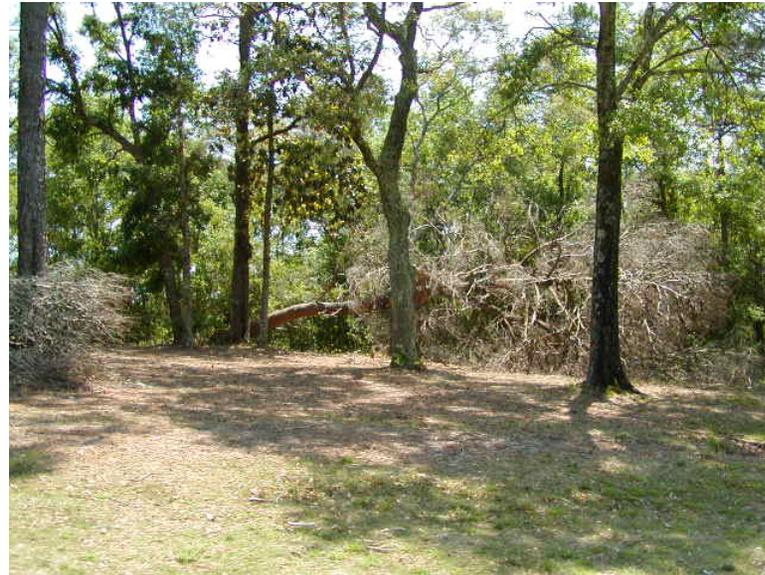
*Tree damaged by 2004 storms are still abundant in out of play areas.*

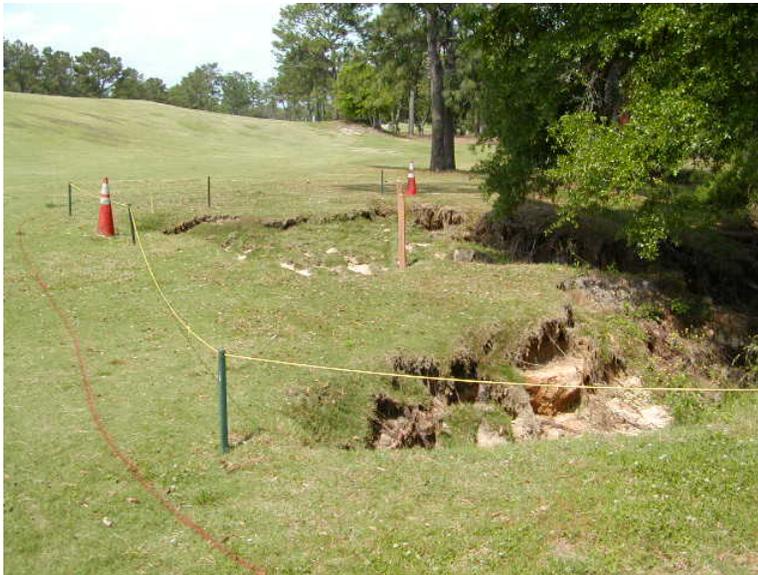
*Erosion problems on the 1st at the Falcon Course.*
